RUBY DAM

Fact Sheet

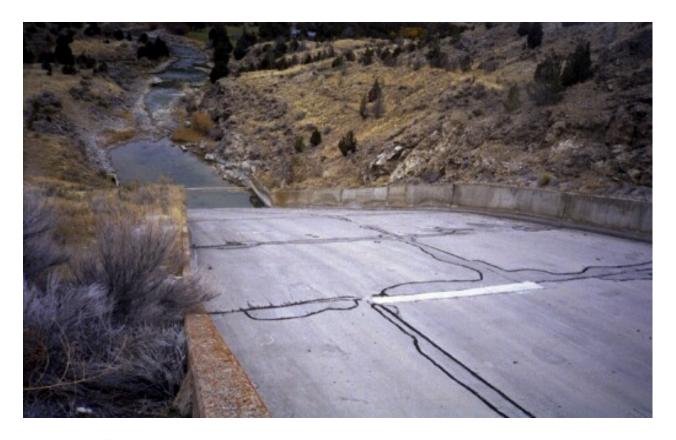
Ruby Dam Spillway

- Severe concrete deterioration exists in the spillway floor and walls. Spillway replacement is needed to correct the deficiencies.
- Excessive seepage may threaten the structural integrity of the spillway.

- A feasibility study to evaluate the problems at Ruby Dam at Ruby Dam was completed in 2007 by HLM Engineering of Billings . The \$285,000 feasibility study cost was authorized by the 2006 Legislature and paid by the DNRC.
- This project is in need of major rehabilitation. The preferred alternative identified in the feasibility study for rehabilitation, which includes a new spillway, outlet conduit, drains, access road and additional storage that could be marketed for beneficial uses, will bring the dam into full compliance with current safety and design standards and greatly reduce the state's liability.
- The proposed rehabilitation will also allow for future hydropower development.
